Citation: Watts, G (2012) A preliminary study of the characteristics of noisy vehicles under cruising conditions – results of roadside measurements. *Acta Acustica united with Acustica*. 98(2): 279-285.

A PRELIMINARY STUDY OF THE CHARACTERISTICS OF NOISY VEHICLES UNDER CRUISING CONDITIONS – RESULTS OF ROADSIDE MEASUREMENTS

by Greg Watts

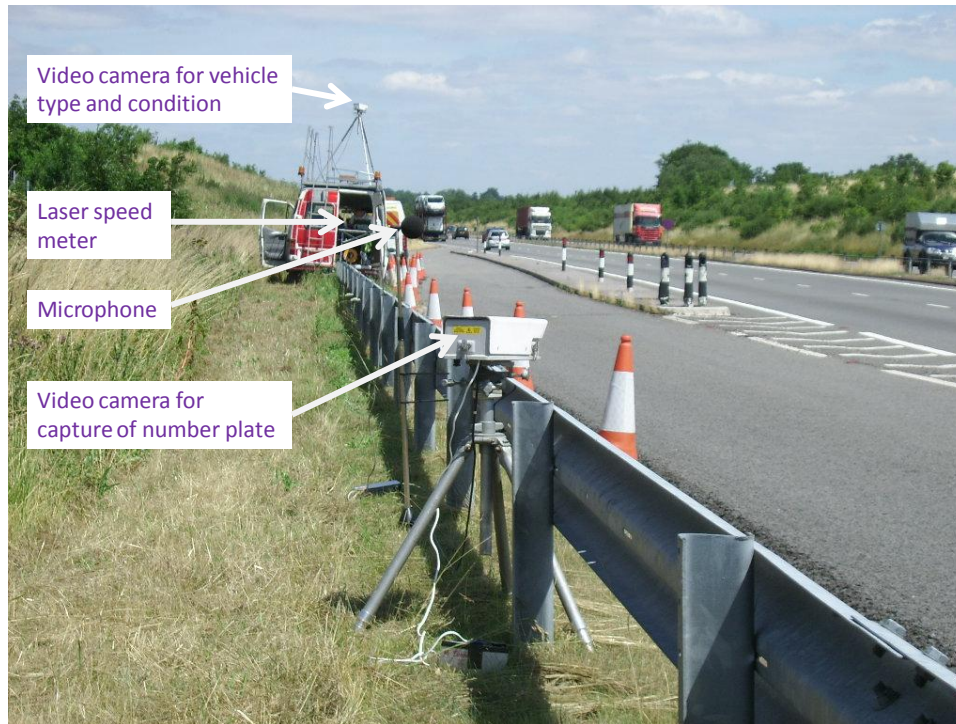
Figure 1: View of measurement set up

at random from the traffic stream. In this way it was expected to reduce the influence on recorded noise of other vehicles travelling on the carriageway. A view of the site is given in Figure 1. The cameras can be seen in the foreground and on top of the mobile laboratory. The microphone stand is just beyond the nearest camera and appears just to the right of the mobile laboratory.

Approaching vehicle speeds were obtained with a laser speed meter. The operator aimed the laser speed meter while seated out of sight in the back of the mobile laboratory. The video cameras were set up to capture images of passing vehicles in order to identify possible noise sources. One camera was mounted at a height of approximately 4m to obtain a view of the load carried by the HGVs and a lower camera at a height of 1.5m was used to obtain images of the rear of the vehicle to obtain information on the number plate, exhaust pipes and tyres.

A microphone was set up at a height of 1.2m and placed approximately 7.5 m from the centre of the nearside lane. This was used to record the maximum A-weighted noise level and the corresponding third-octave band spectra of the selected vehicles. For this purpose a Bruel and Kjaer third-octave real time analyser was used (B&K 2144). A DAT tape recorder was employed to provide a continuous sound record.

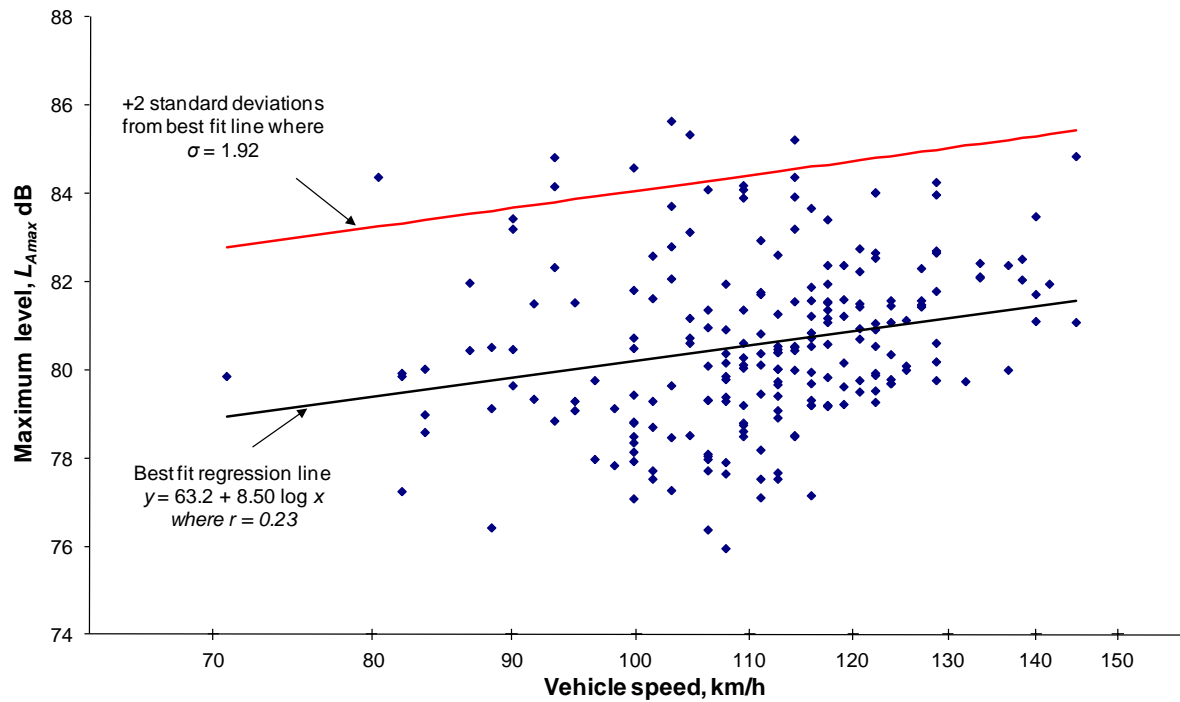
Figure 2: Category 1 (light vehicles) at Site 1

Figure 4 shows the scatterplot of maximum A-weighted pass-by noise levels against the logarithm of speed. The regression line has been added together with the line at 2 standard deviations above the regression line. Using normal (Gaussian) statistics it would be expected that approximately 2.3% of vehicles will exceed this line. With 219 vehicles in the sample the expected number is 5 vehicles. In Figure 4 it can be seen that 7 vehicles were above the line.

Examining overall levels for each vehicle category in Figures 2, 4 and 6 it can be seen that there is a tendency for L_{Amax} to increase with speed which is predicted with vehicle noise emission models that have examined both rolling and propulsion noise [6] and from roadside measurements [7]. However, although the speed coefficient (slope) is within the expected range for heavy vehicles it appears low in the case of light and medium heavy vehicles. The reasons for this are uncertain though it is clear that because the correlation coefficients are low the regression line is ill defined and the confidence limits for the slopes will be relatively large. The subsequent analysis was based mainly on the third octave analysis of pass-by noise together with the associated images from the video records. Body rattle noises were considered to cause the significant elevation of levels of around 5 dB(A) or more in several third-octave bands above 800Hz and above. In the case of exhaust noise levels were elevated by around the fundamental firing frequency of the engine (typically in the 63 to 125 Hz range). Recent work has shown that where body rattle noise is heard from passing vehicles the frequencies in a broad band above 800 Hz are significantly elevated above similar vehicles with no identifiable noise source (see section 8.3.1 of [7]). For discernable exhaust noise the frequencies are much lower e.g. in the 63Hz octave band levels were nearly 10 dB(A) higher. This is to be expected based on the fundamental firing frequency e.g. for a V8 four stroke diesel engine running at 1000 rpm the fundamental is at 67 Hz.

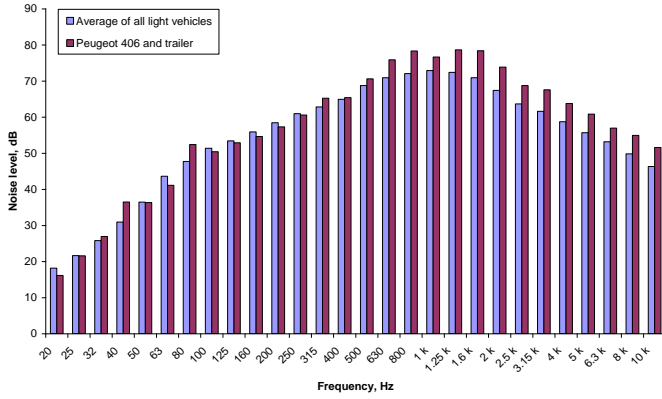
(a) Saloon car and trailer

It can be seen in Figure 3(a) that in the case of the saloon car towing the trailer there is an excess of noise above 630 Hz. This is consistent with rattle noises from the relatively old trailer. For the vintage sports car (Figure 3(b)) there is tonal noise around 160Hz. This is likely to be exhaust noise resulting from harmonics of the fundamental firing frequency of the engine.

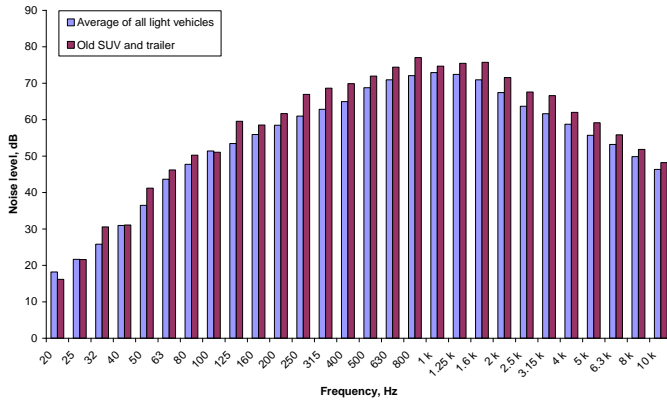
(c) Old SUV and trailer

Figure 3(c) shows that, for the SUV and trailer, the noise levels are generally higher than the average for a broad range of frequencies. This indicates that the main sources of noise on the vehicle, i.e. engine, exhaust, rolling noise, are all producing higher noise levels than the average vehicle in the sample. SUVs are generally noisier than saloon cars both in terms and of propulsion noise and rolling noise. The fact that it was relatively old is also considered to be a factor. The trailer would also have produced additional noise especially rolling and rattle noises.

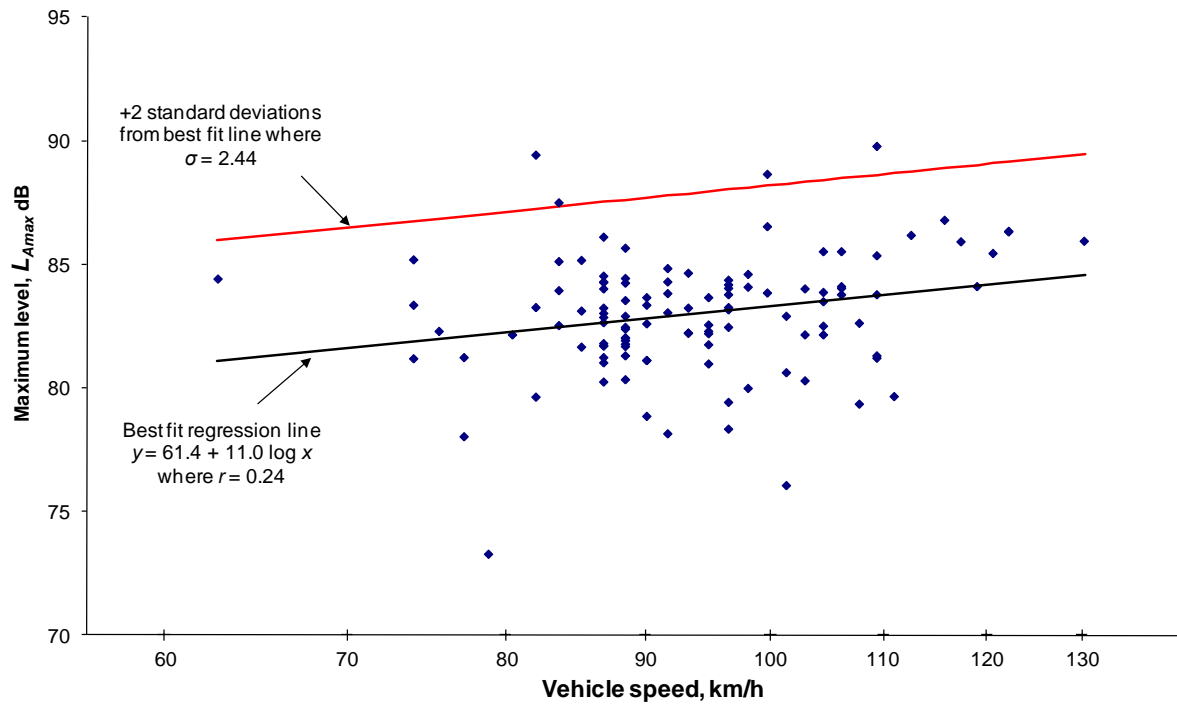
Figure 4: Category 2 (medium heavy) vehicles

Figure 4 shows the scatterplot of maximum A-weighted pass-by noise levels for category 2 vehicles against the logarithm of speed. The regression line has been added and the line at 2 standard deviations above the regression line. Using normal statistics it would be expected that approximately 2.3% of vehicles will fall above this line. With 115 vehicles in the sample the expected number is 3 vehicles. In Figure 4 it can be seen that in fact 3 vehicles gave noise levels that were above the line.

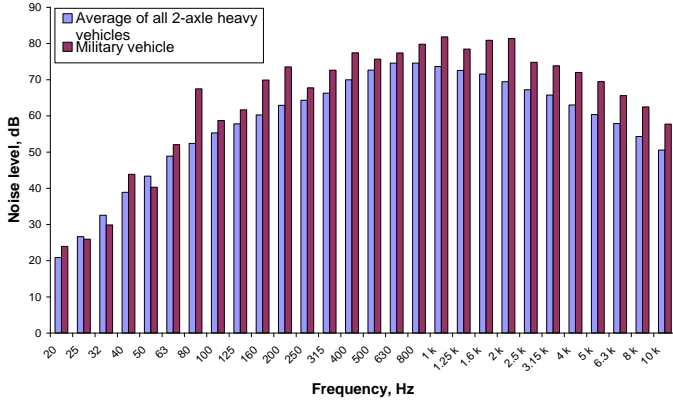
(a) Military truck

The third octave band spectra of these vehicles are given in Figure 5. It can be seen that the military vehicle (Figure 5(a)) is excessively noisy across the spectrum. There is a sharp peak at 80 Hz suggesting exhaust noise with possibly a harmonic occurring at 160 Hz. Above 800 Hz there is a general increase suggesting either tyre noise (from possibly off-road tyres with large tread blocks)) or body rattle noise from the mechanical digger. Possible exhaust noise peaks can also be seen in Figure 5(b) and (c) at the lower frequencies. The flapping canvas is probably responsible for the elevated levels shown in Figure 5(b). The tonal components at 1.25 and 1.6 kHz may result from transmission whine.

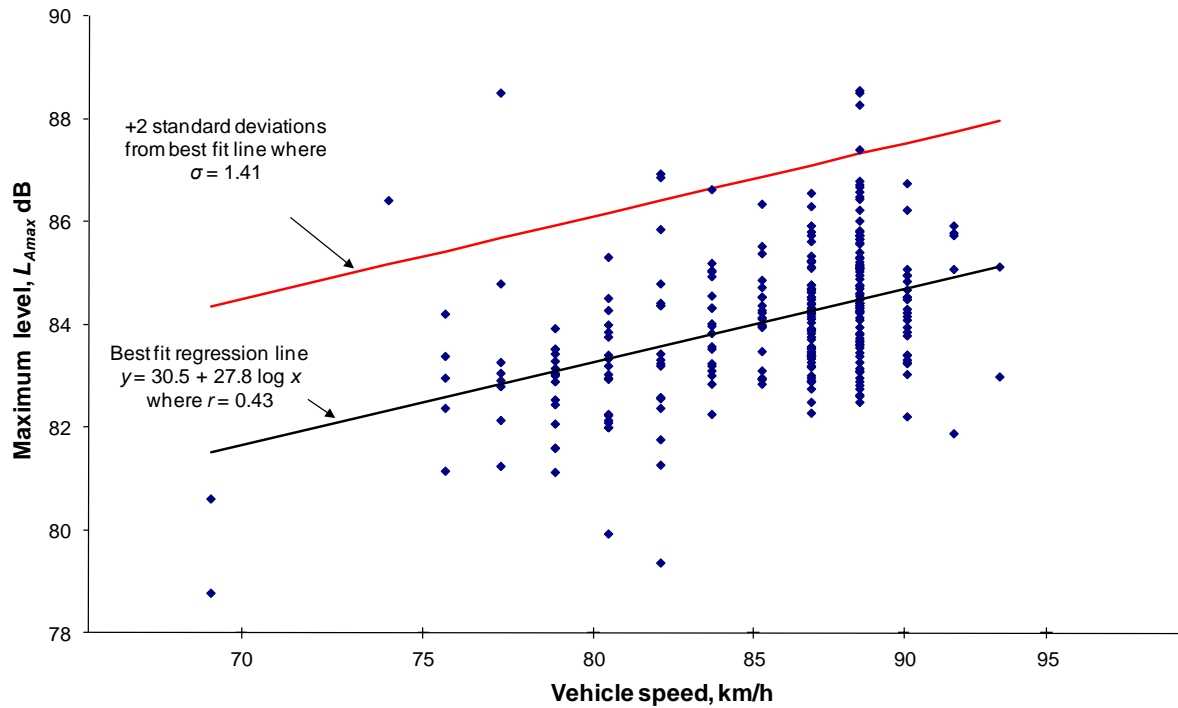
Figure 6: Category 3 (heavy vehicles)

Figure 6 shows the scatterplot of maximum A-weighted pass-by noise levels for category 3 vehicles against the logarithm of speed. The regression line has been added and the line at 2 standard deviations above the regression line. Using normal statistics it would be expected that approximately 2.3% of vehicles will fall above this line. With 280 vehicles in the sample the expected number is 6 vehicles. In Figure 6 it can be seen that in fact the noise levels from 7 vehicles are on or above the line.

Table 3 list the characteristics of the vehicles which lay above the line drawn at 2 standard deviations from the best fit regression line. It can be seen that 6 out of the 7 noisiest vehicles were transporters. In most cases body rattle noises of the trailer was thought most likely to be responsible for these sounds.

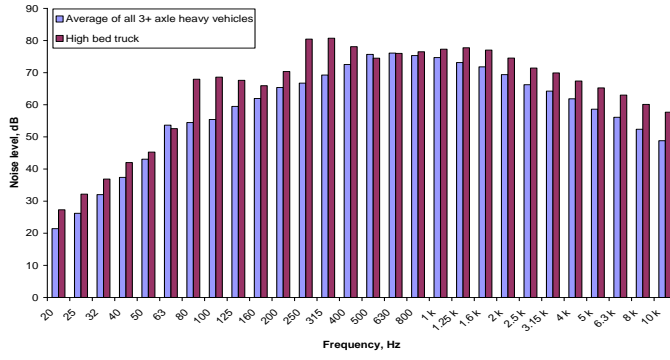
(a) High load bed truck (3 axes)

The third octave band spectra of these vehicles are given in Figure 7. It can be seen in Figure 7(a) that the high load bed truck with 3 axles is noisy at low, mid and high frequencies. The relatively high levels at low and mid frequencies are probably due to engine and exhaust noise though vibration of panels (body “boom”) may be a factor. At high frequencies rattle noises are probably responsible. The crane behind the cab would probably be a significant source of rattle noise. The remaining vehicles are all transporters with 4 of the 6 being unladen. Loose chains, safety fences around load beds, ramps are all source of rattle noise. The open frame and lack of streamlining would also contribute to increases in aerodynamic noise though this is thought to be relatively low at speeds around 90 km/h. The effect of these sources is a significant increase in noise levels above 800 Hz as can be seen in all the Figures 7(b) to 7(g).

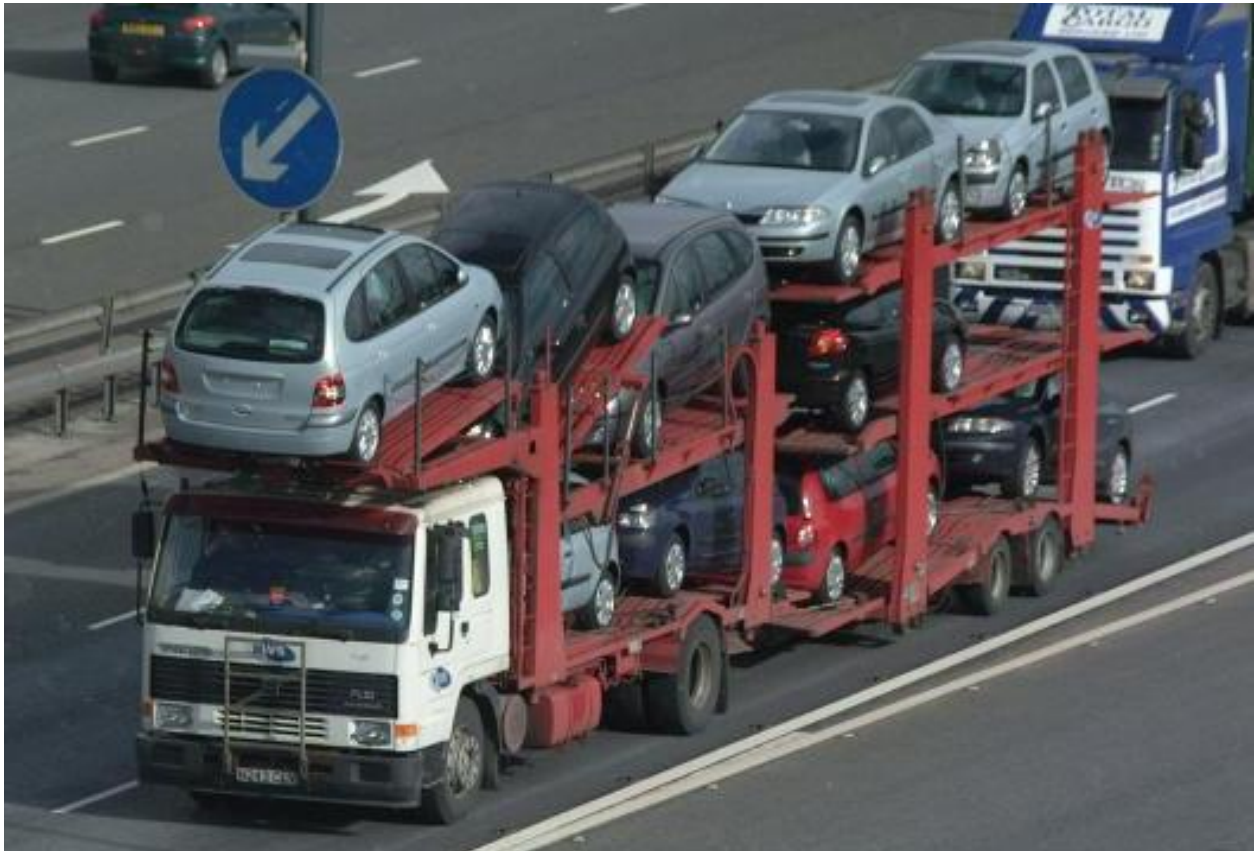
Figure 8: Typical car transporter

A typical car transporter is shown in Figure 8 where the loose chains are evident alongside the car decks.

Inspection of the images reveals some of the reasons for the rattle noises on transporters. The sources are likely to be metal to metal impact sounds due to loose:

- chain safety fences along the sides of the bays,
- vehicle securing chains,
- vehicle ramps,
- components on hydraulic hoists,
- components on the vehicles being transported (e.g. construction site vehicles).

The UK code of practice for body rattle noise [8] provides guidance on methods of preventing such noise. It is likely that there are particular challenges in reducing rattle noises for this type of vehicle because there are many loose metal components and more detailed investigations of the major sources and their elimination are required.
